AQUATIC AND RIPARIAN HABITATS

Stream Reach Description

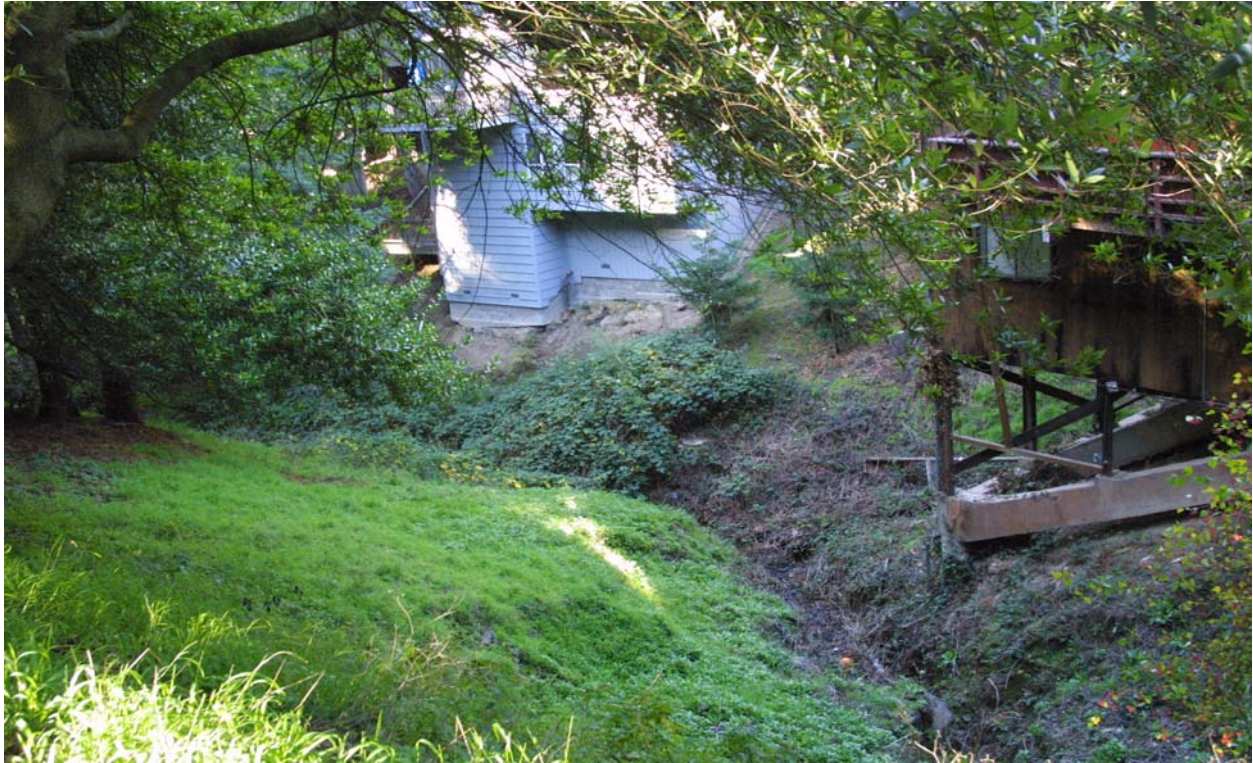
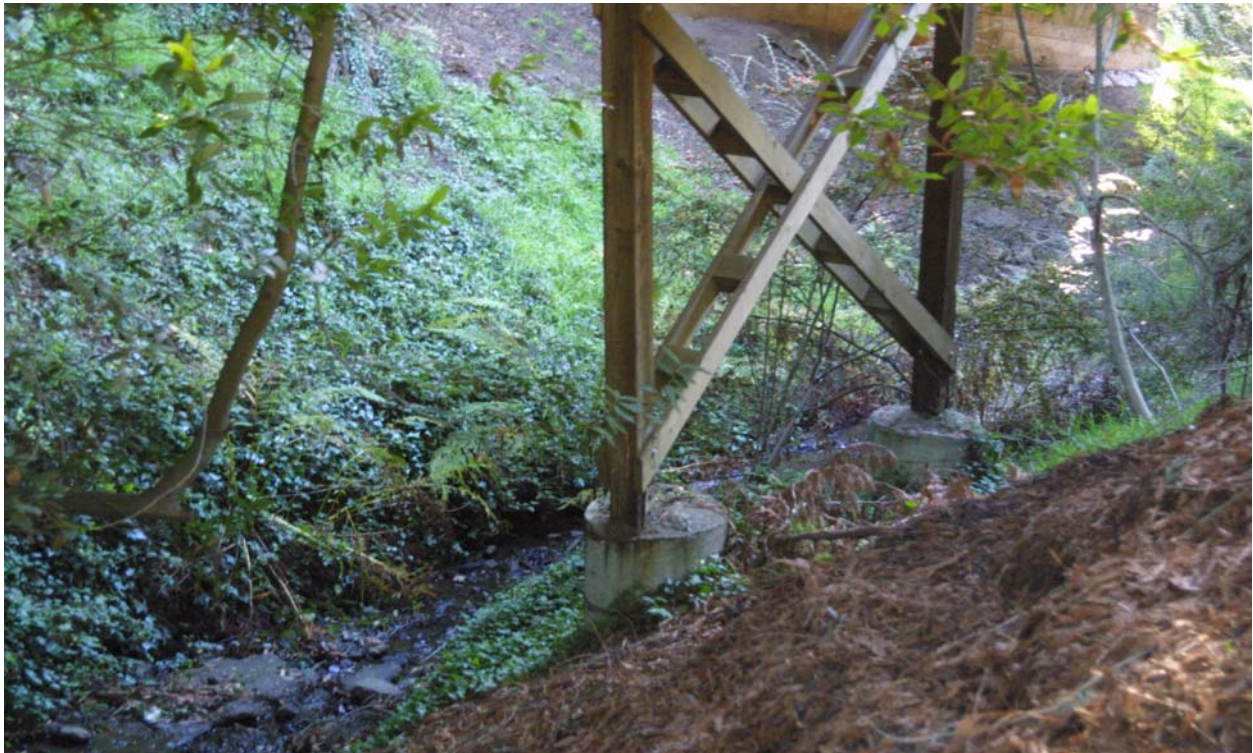
Most of Cobbledick Creek and its tributaries have open channels with seasonal flow. With the exception of two areas, however, this sub-basin is private residential land. In addition, in many areas of this sub-basin homes border the creek or have foundations or deck piers next to or in the creek (Figure 56). In these private creeks, control and eradication of invasive plants such as broom, Himalayan blackberry, cape ivy, Algerian ivy, and blue periwinkle will reduce the spread of these problem plants into downstream habitat areas. Erosion control and bank stabilization may also be needed. Native shrubs and trees such as toyon, manzanita, oaks, and madrone occur as natural vegetation.

Figure 56: Houses line the tributary channels in the Cobble Dick Creek sub-basin. House and deck foundations are located within the area of the channel that is subject to bank erosion and failure.

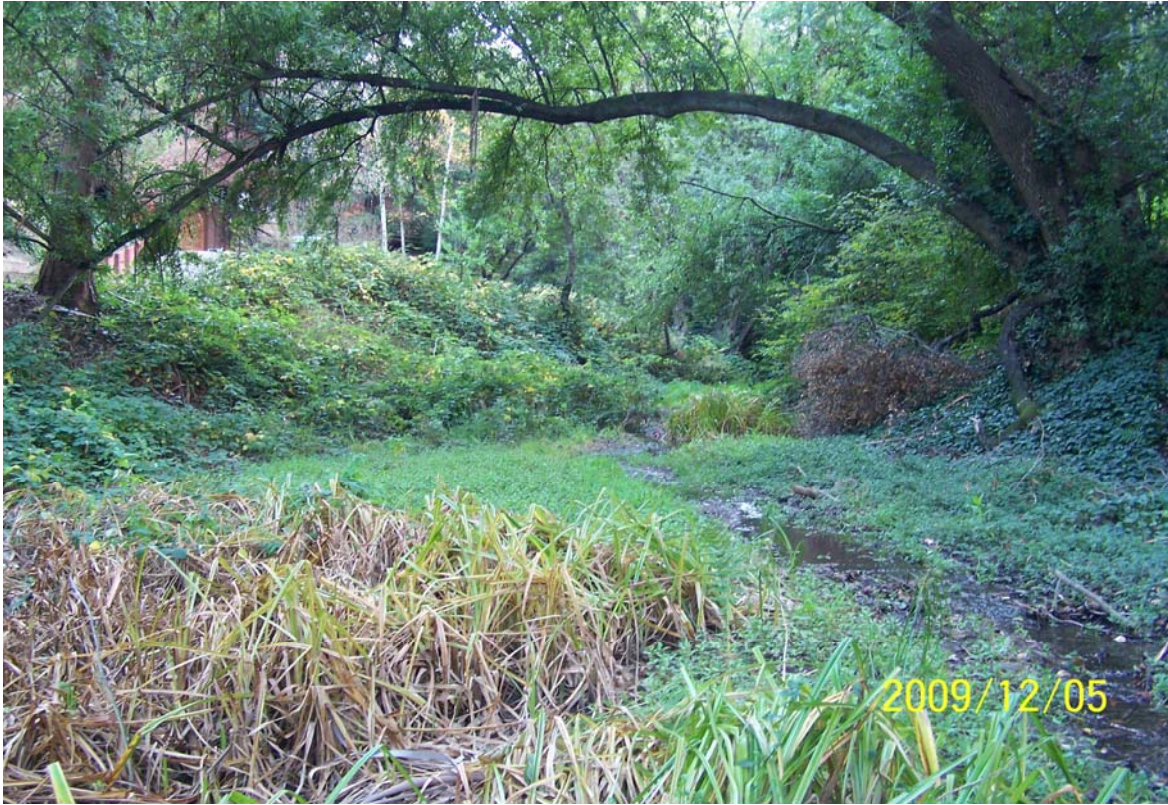
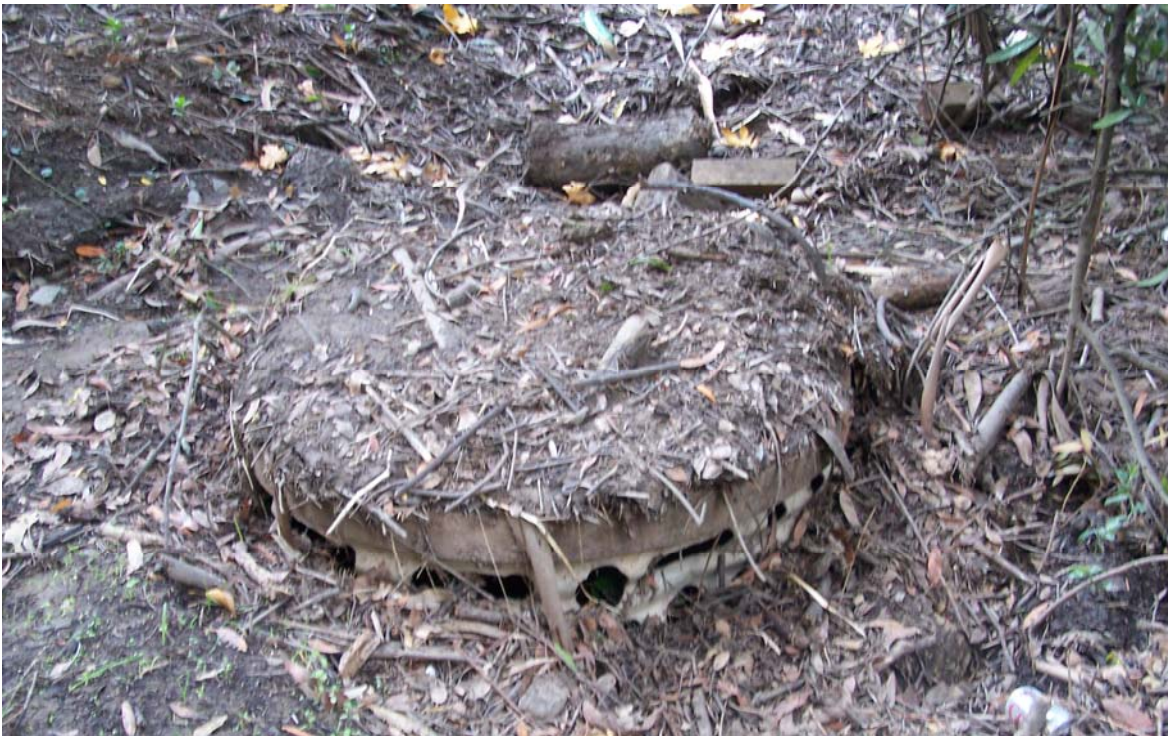
This reach along Larry Lane is bordered with houses. The channel is semi-confined between hillslopes and much of the former floodplain is filled with houses. The channel bed is fine sediment and gravel. Mixed conifers line the creek and Eucalyptus, Algerian ivy, and broom are common. A sediment/detention basin blocks the channel near the Ascot Road crossing (Figure 57). The dam creating this basin was overtopped and eroded portions of the dam and Larry Lane road fill. Downstream from this basin the creek channel consists of fill with a culvert and has a house on the fill. There is erosion at the outlet (C-2-01; Figure 79) Downstream of the Ascot Rd. crossing the creek channel is filled and the creek goes through a culvert under Joaquin Miller Elementary/Montara Middle schools.

Figure 57: Top: Tributary to Cobble Dick Creek along Larry Lane (CC1) flows into a sediment basin. Bottom: Lack of maintenance of basin shows in this buried and largely nonfunctional standpipe.

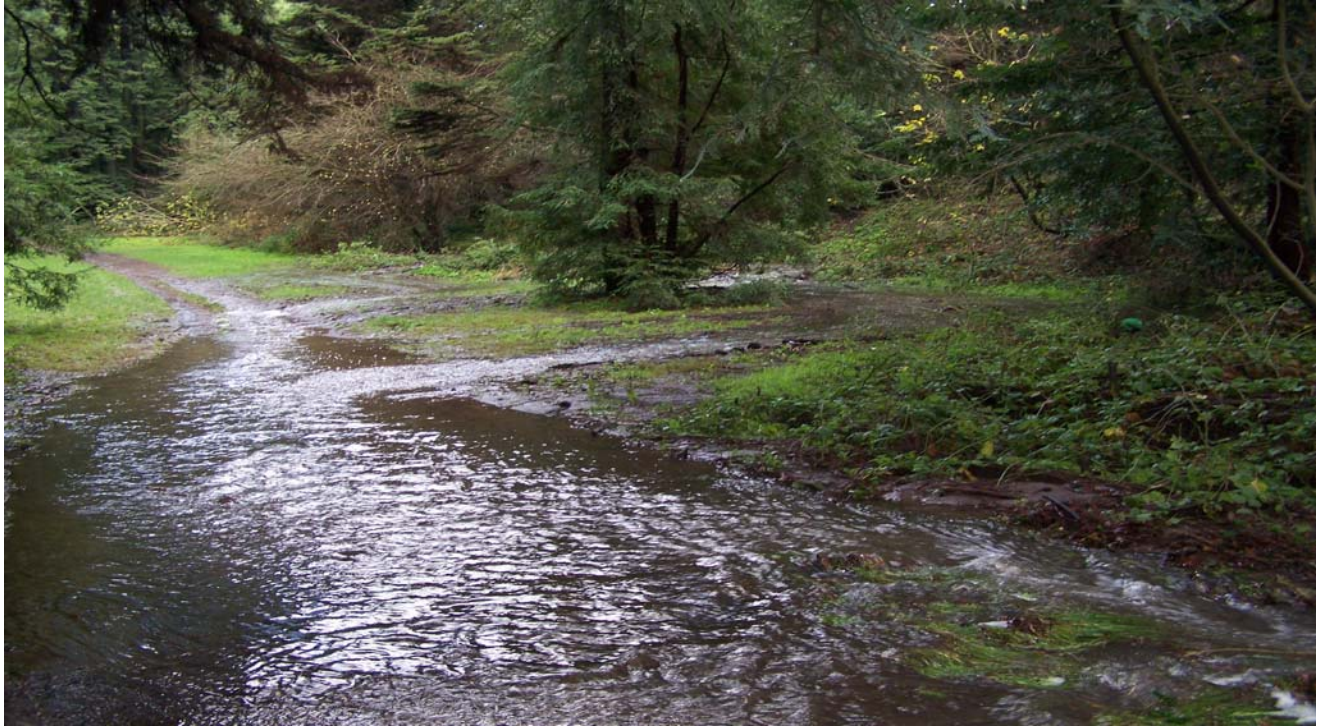
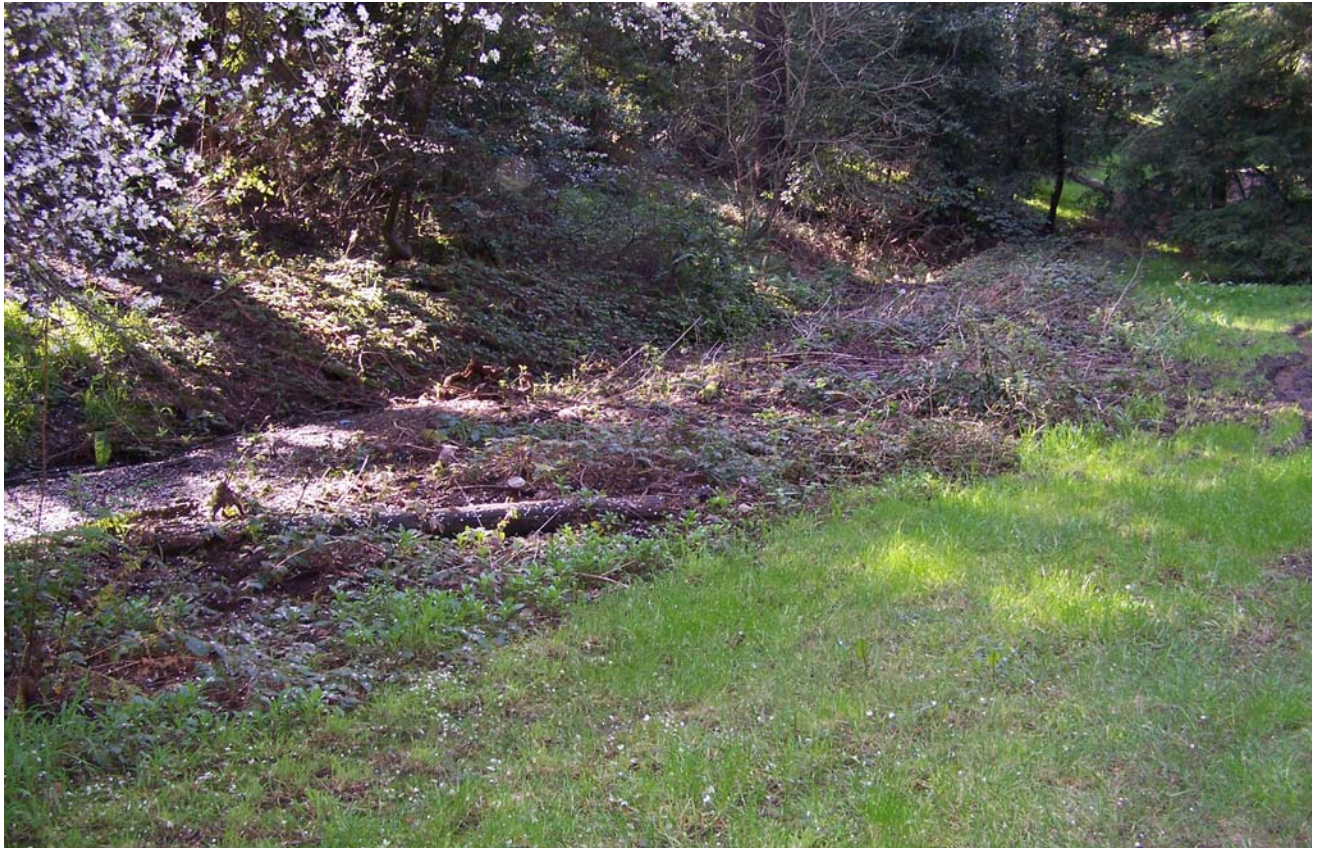
Figure 58: Palo Seco Creek (PSC1) overflows onto a grassed floodplain and trail during larger flow events.

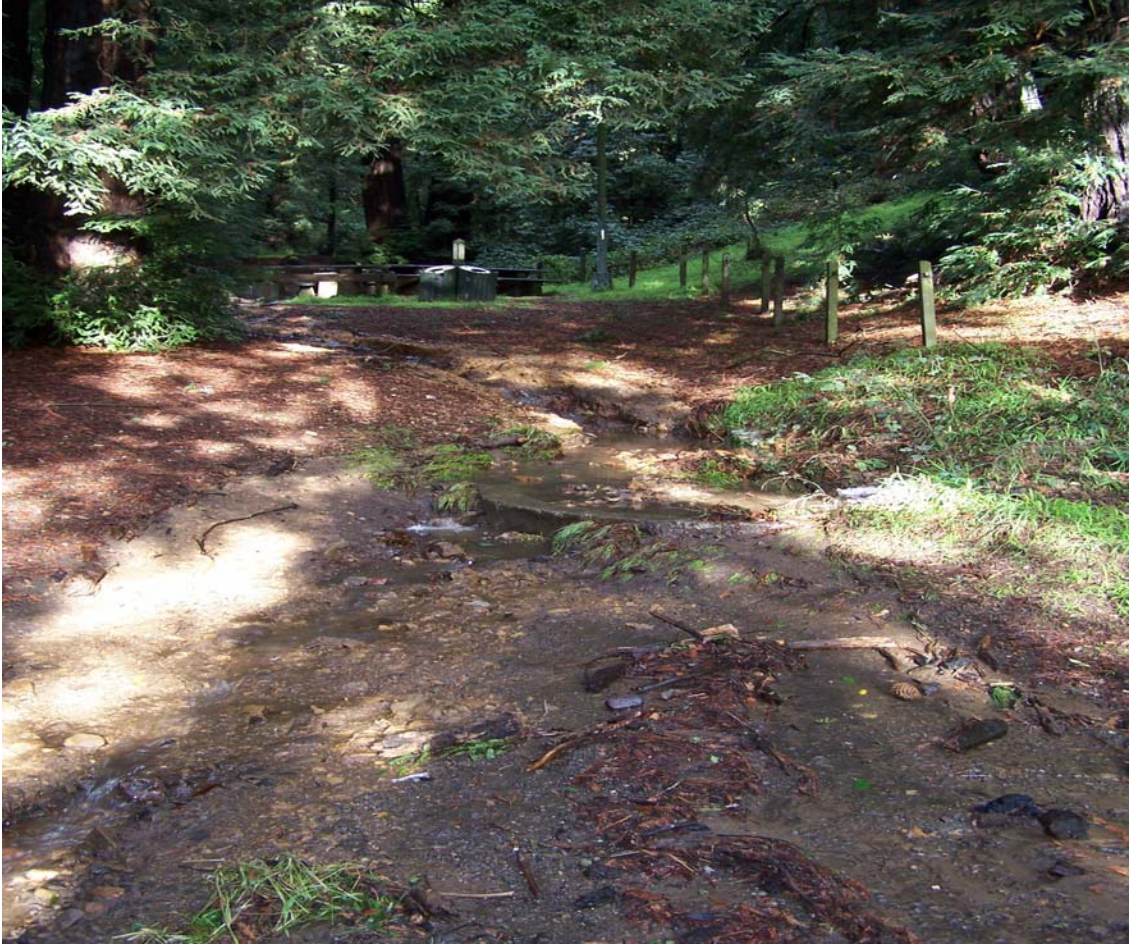
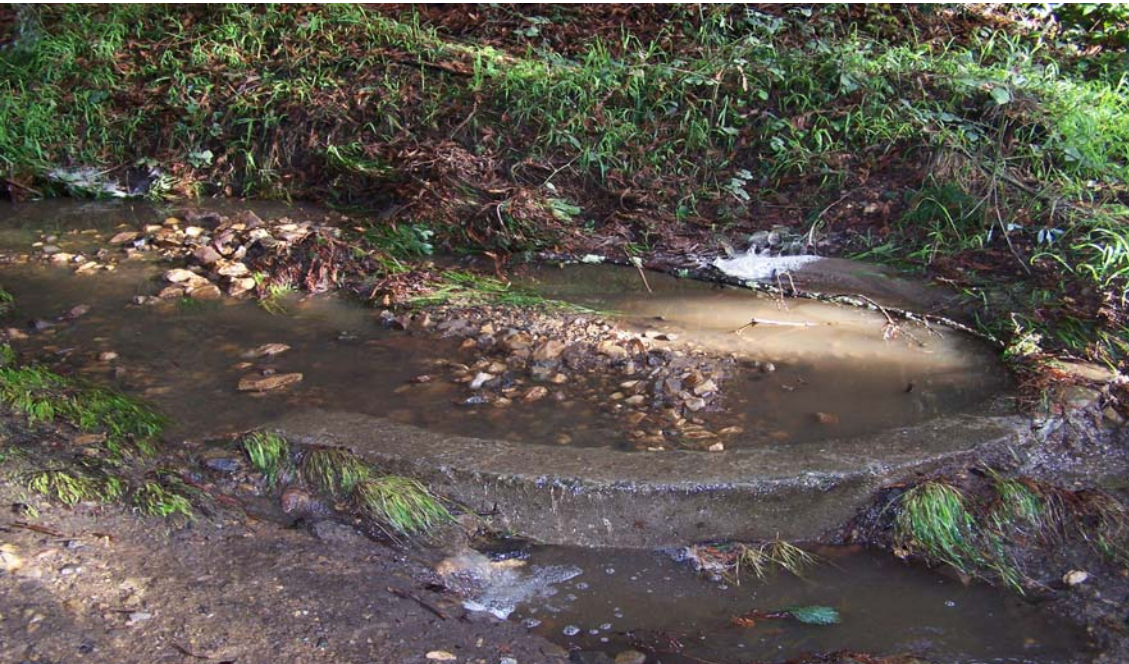
This reach of creek was culverted to create a meadow. This reach was likely lined by redwoods prior to clearcutting in the 1860s and park development projects in the 1930s and 1940s. This reach includes the confluence with Fern Ravine Creek, which is culverted from a picnic area to its confluence with culverted Palo Seco Creek. The drop inlet for Fern Ravine Creek frequently fills with bedload, and water creates an overland course to meet the open channel of Palo Seco Creek (Figures 59 and 60).

Figure 59: Top: Fern Ravine Creek, part of PSC2, in Joaquin Miller Park after the Jan 1, 2006 flood where the creek flowed out of its concrete channel and overland. Bottom: Filled-in culvert drop inlet.

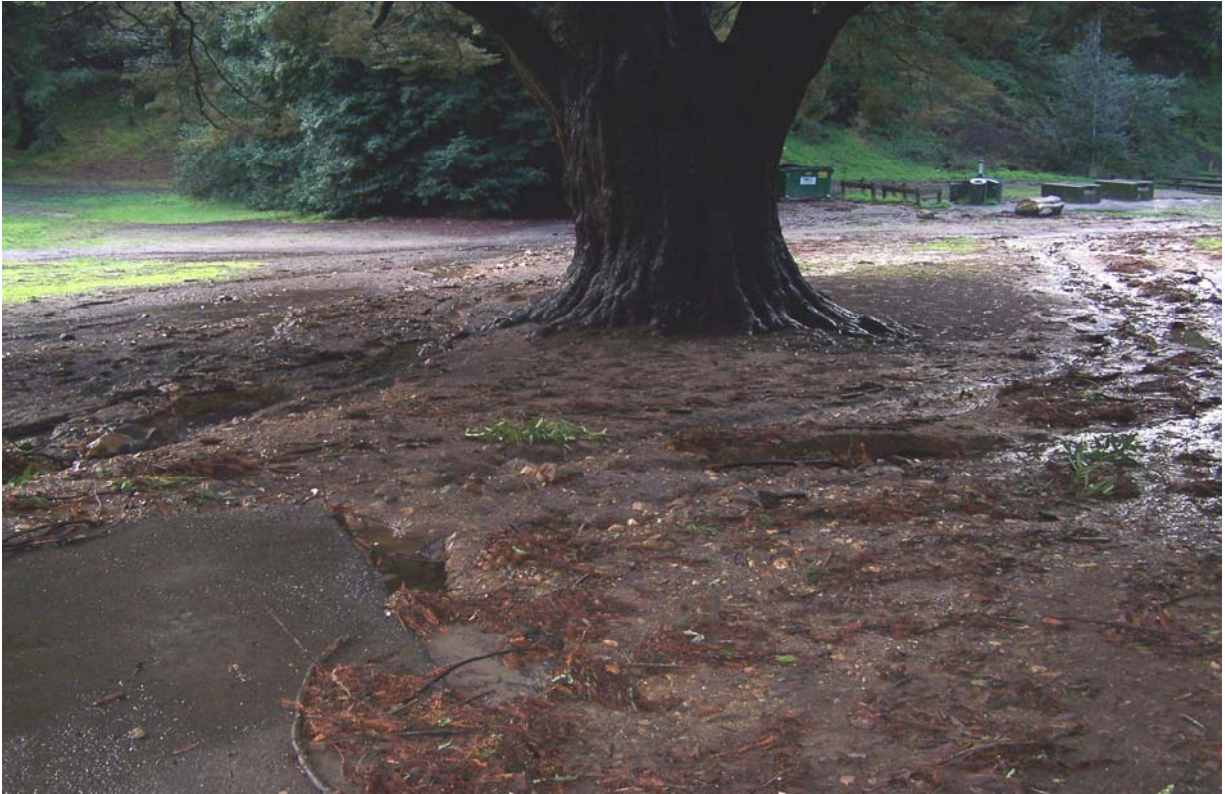
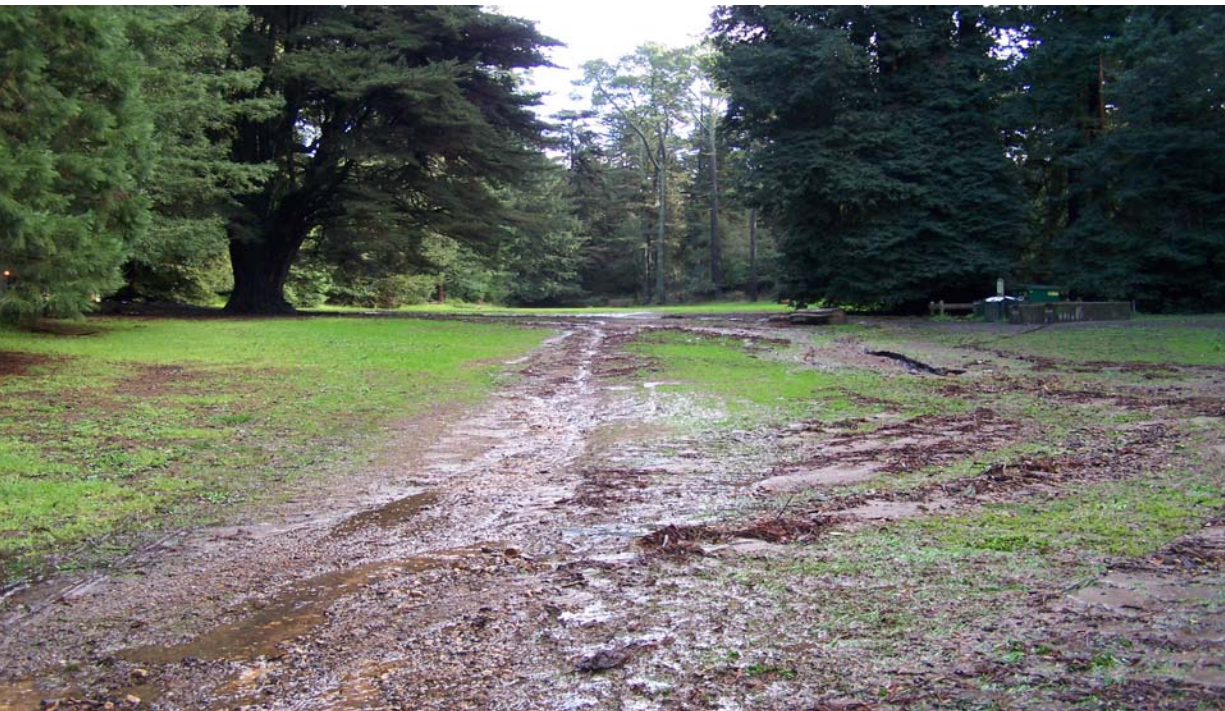
Figure 60: Top: Fern Ravine Creek overland flow crosses the trail and spreads out into the middle and lower meadow area in PSC2. Bottom: Fern Ravine Creek joins Palo Seco Creek where it comes out of the culvert into a natural channel just downstream of the meadow.

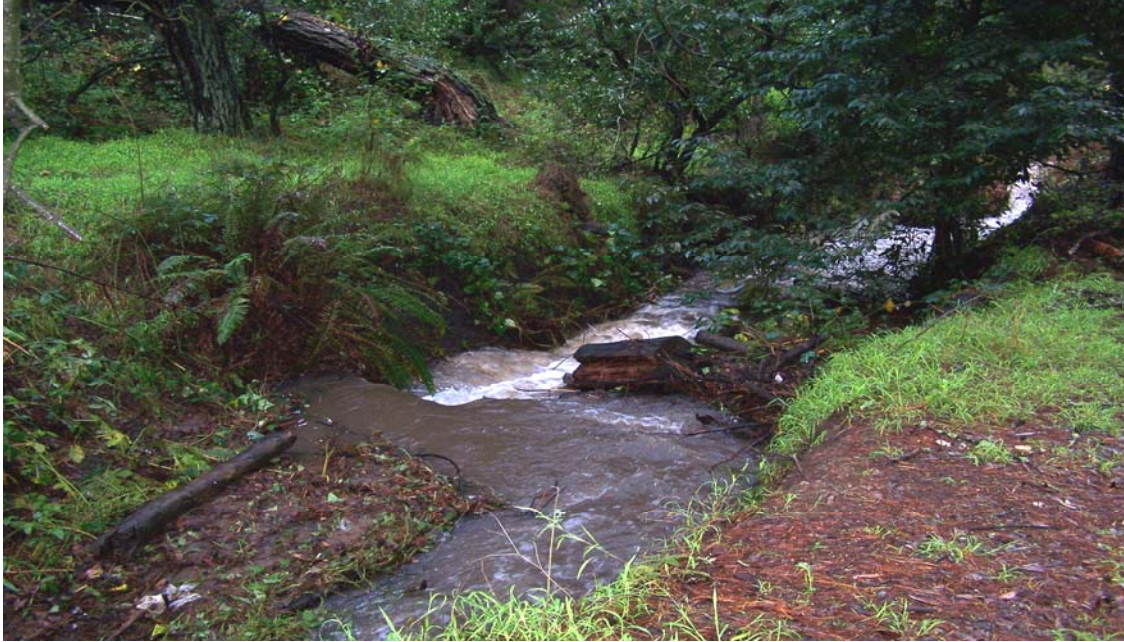
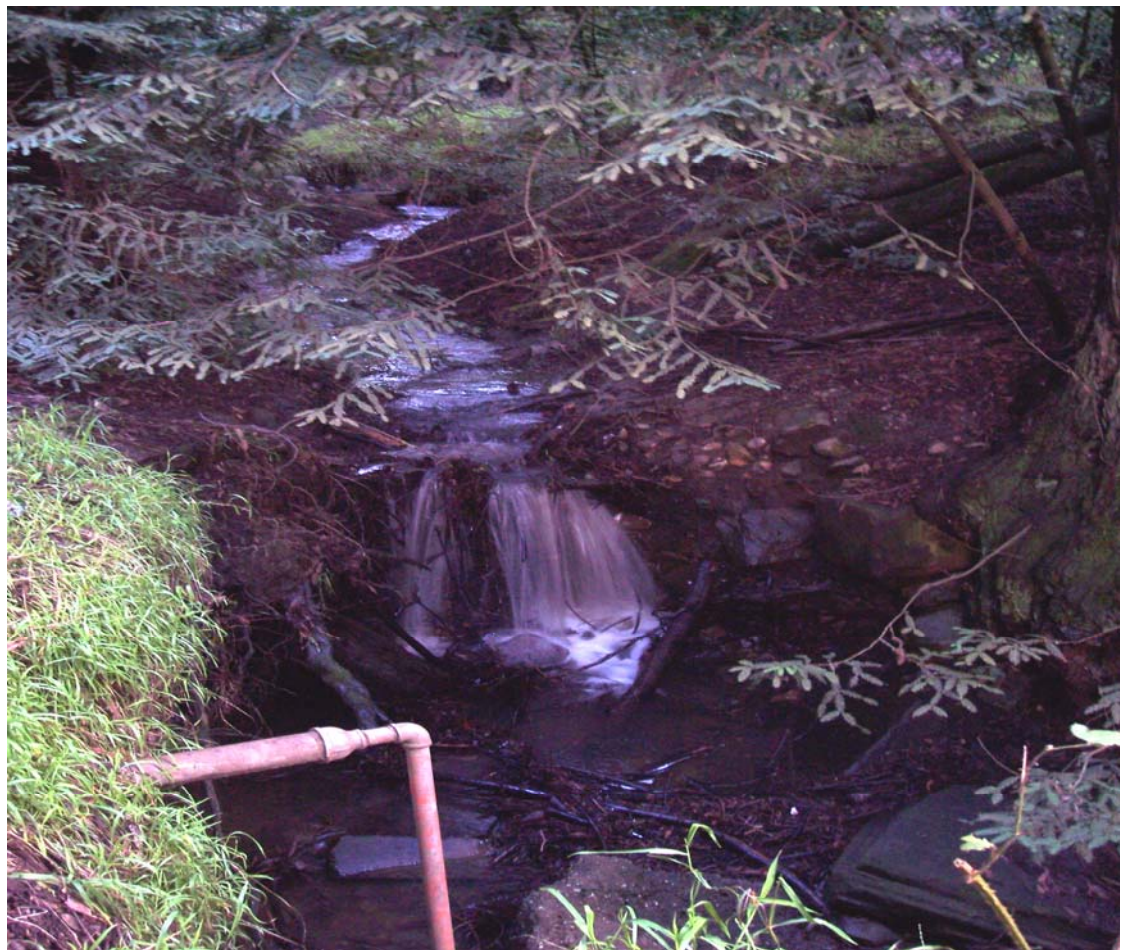
This reach of Palo Seco Creek stretches from the culvert outlets at the downstream end of the meadow to the confluence with Cinderella Creek (Figures 61 and 62). The slope of the creek bed increases over this reach and the channel is semi-confined by adjacent hillslopes. The channel bed is fine sediment with some gravel and the channel contains several knickpoints (Erosion Sites 3 and 4, Figure 90). The creek channel is incised below these knickpoints and several trees have been undercut on the banks. Vegetation density along the creek is moderate with coast redwoods, California bay laurel, and live oak and an understory of Himalayan blackberry. The Lacan BMI station is located in this reach which showed good aquatic habitat conditions.

**Figure 61: Top: Palo Seco Creek at beginning of reach PSC3.
Bottom: Knickpoint in Palo Seco Creek where tree roots are serving as a grade control structure.**

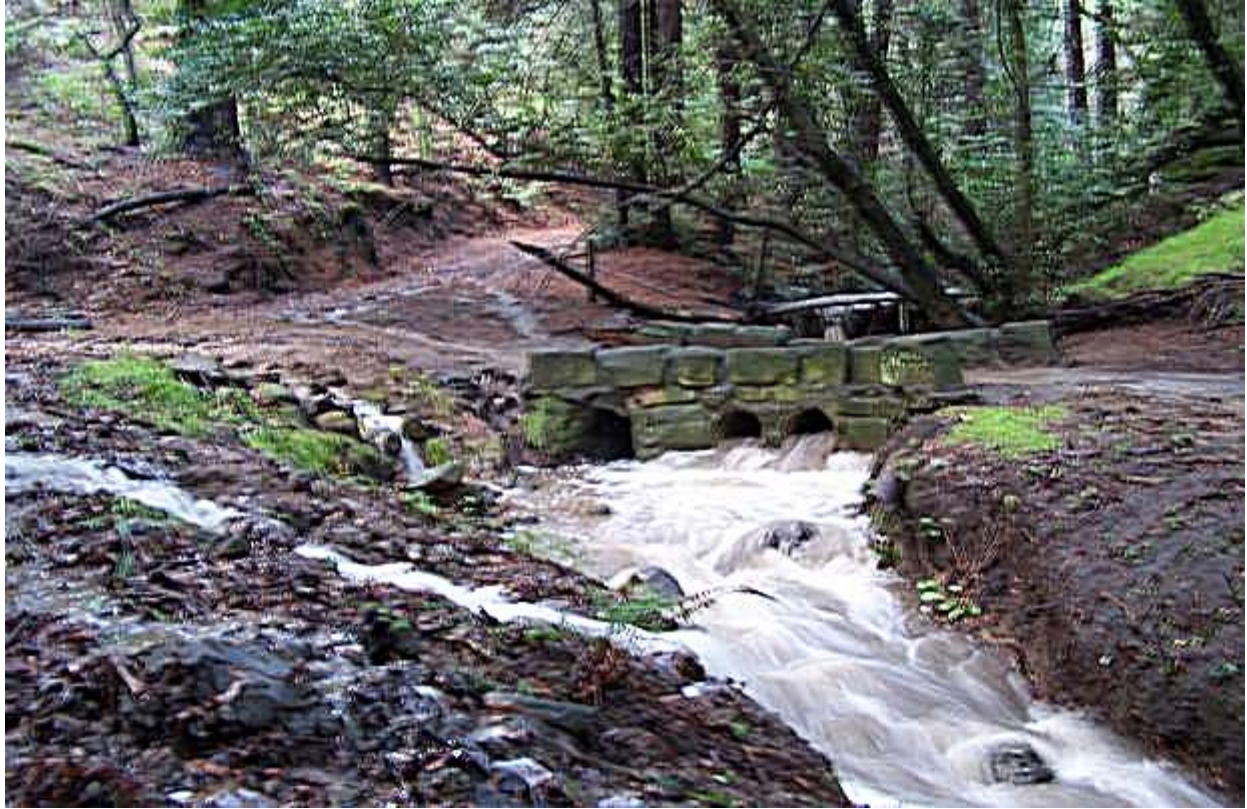
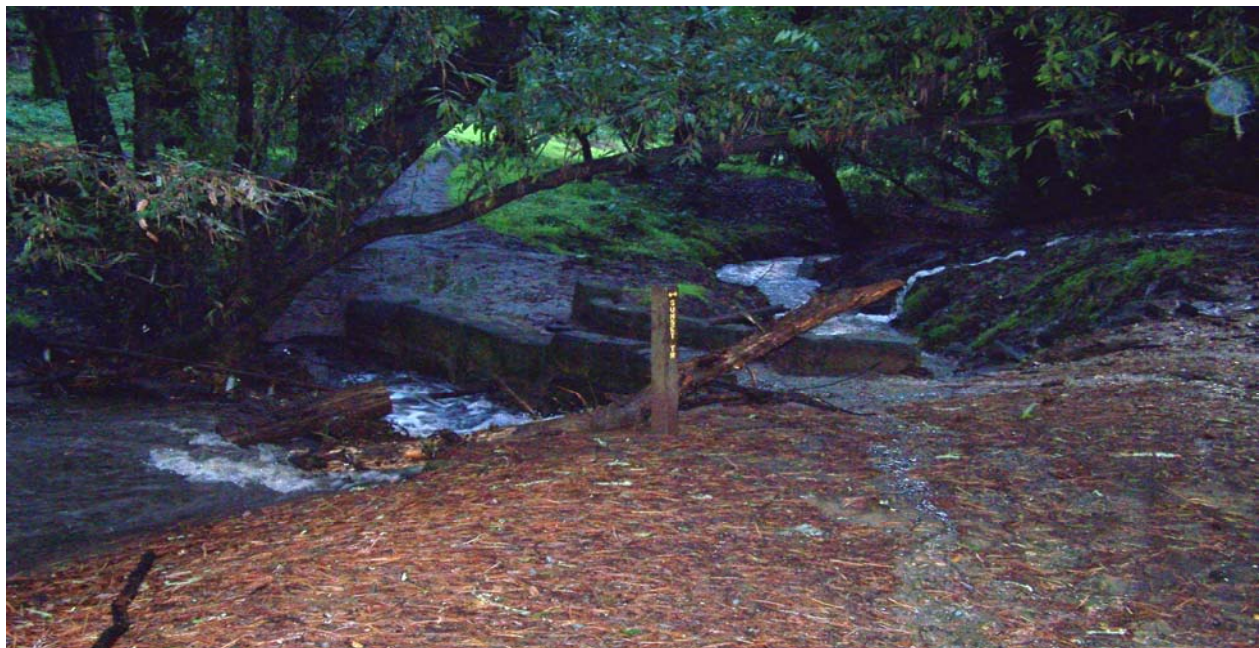
Figure 62: Top: Palo Seco Creek (PSC3) in the Jan. 1, 2006 flood event. Bottom: Small trail bridge with culverts serves as a grade control structure for Palo Seco Creek. Small trash rack visible upstream is also a grade control structure. Note sediment runoff from adjacent trails.

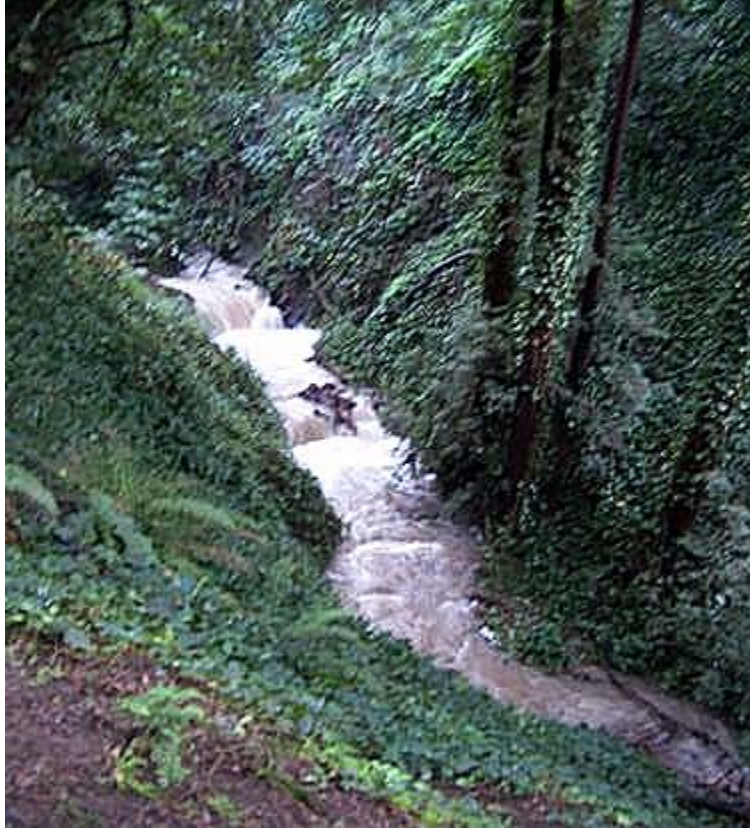
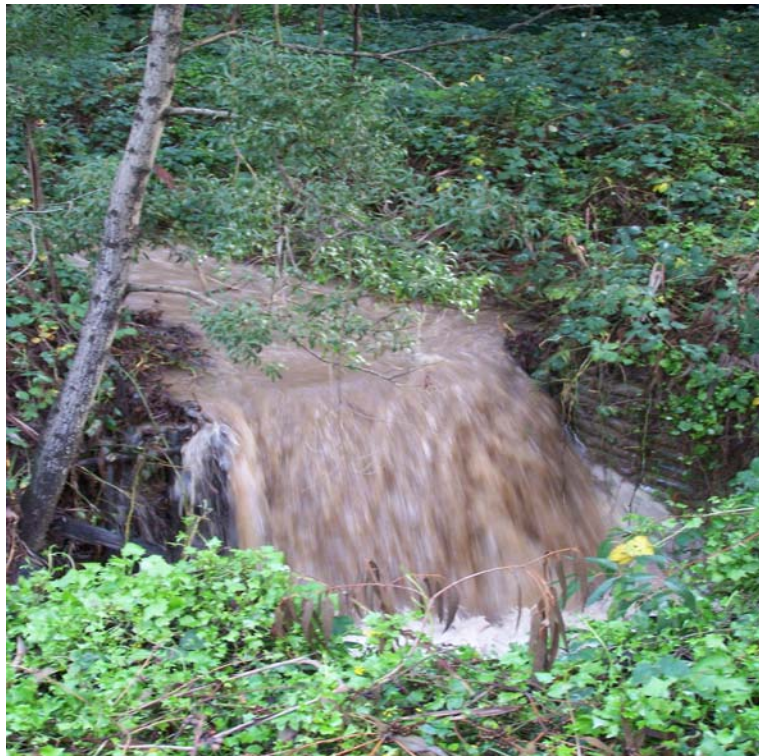
This steep rockbound channel is lined by redwood and California bay laurel trees. Many trees, however, are covered with parasitic Algerian ivy and numerous invasive non-native holly trees are growing in the redwood forest (Figure 63). A SWAMP station and FOSSC bacteria sampling station are located at the downstream end of this reach.

Figure 63: Palo Seco Creek (PSC4) during the Jan. 1, 2006 flood in its rock canyon and at its terminus at Joaquin Miller Court. Note Algerian ivy covering trees and slopes.

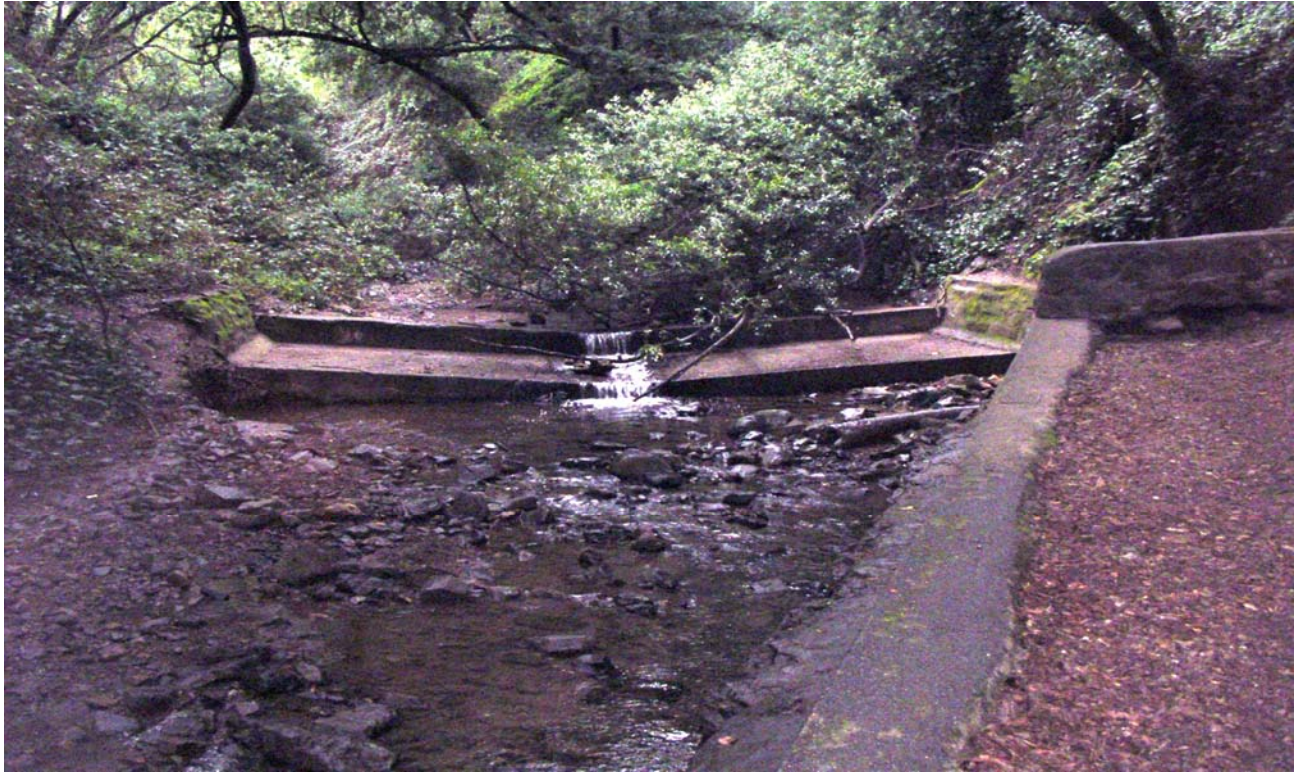
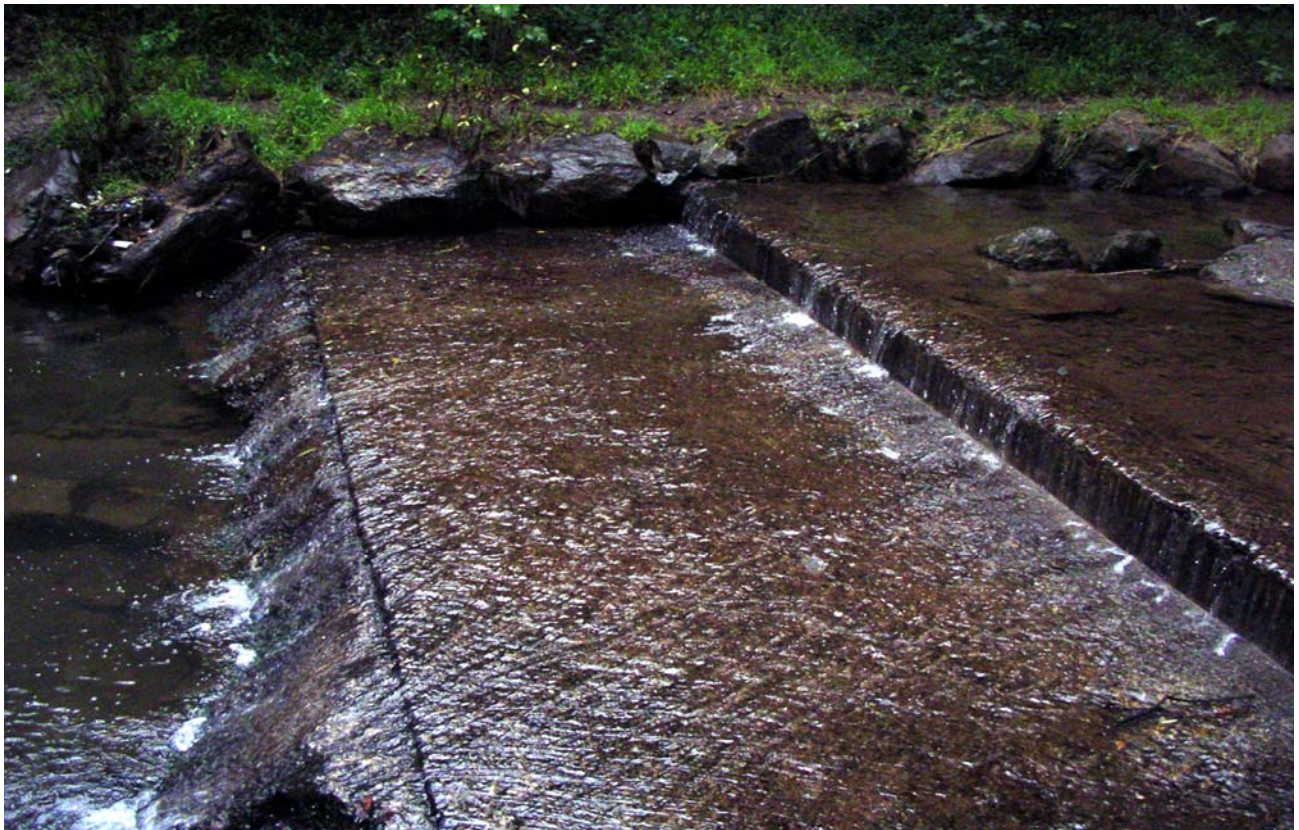
Figure 64: These photos are examples of the drop structures in Sausal Creek (SC1) in Dimond Canyon.

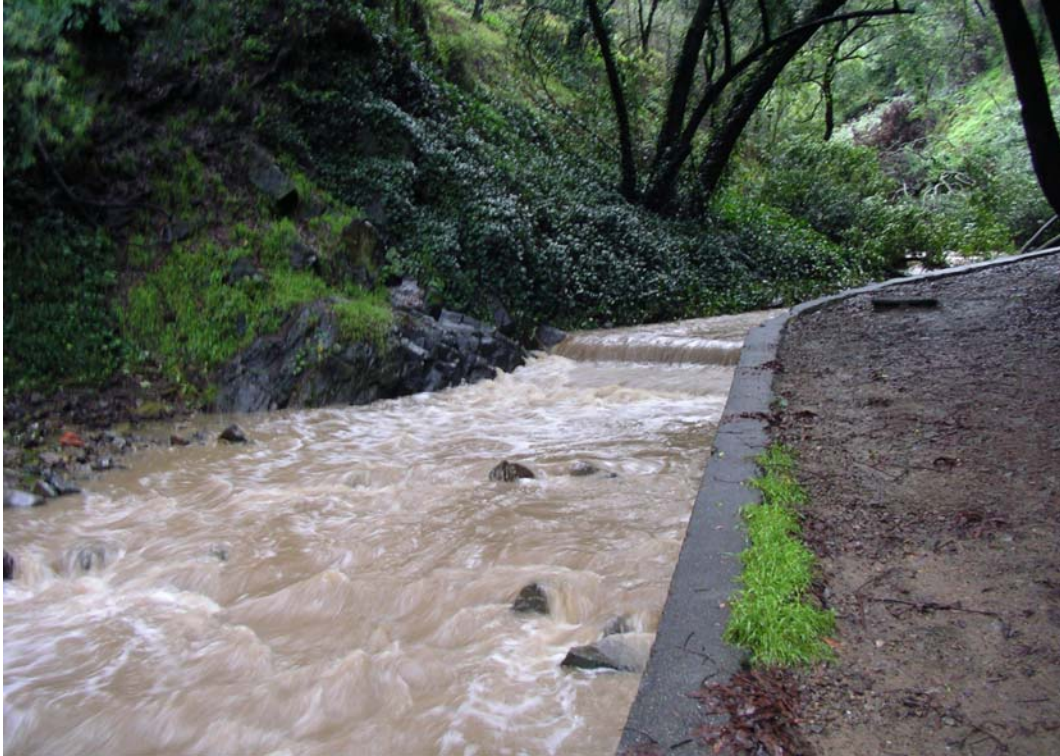
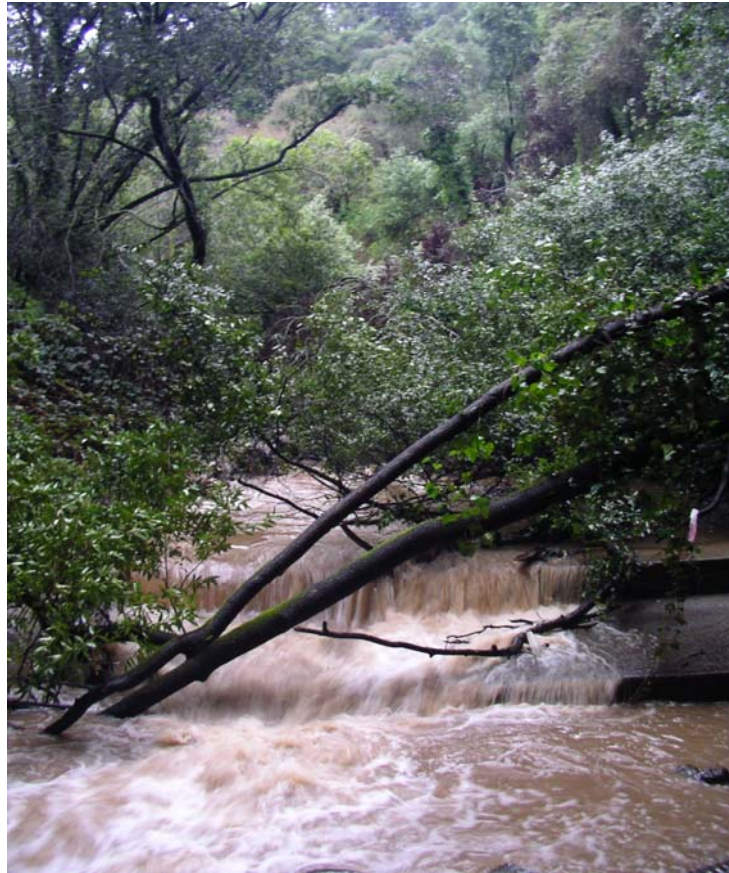
Figure 65: Grade control structures in SC1 during the Jan.1 2006 flood.

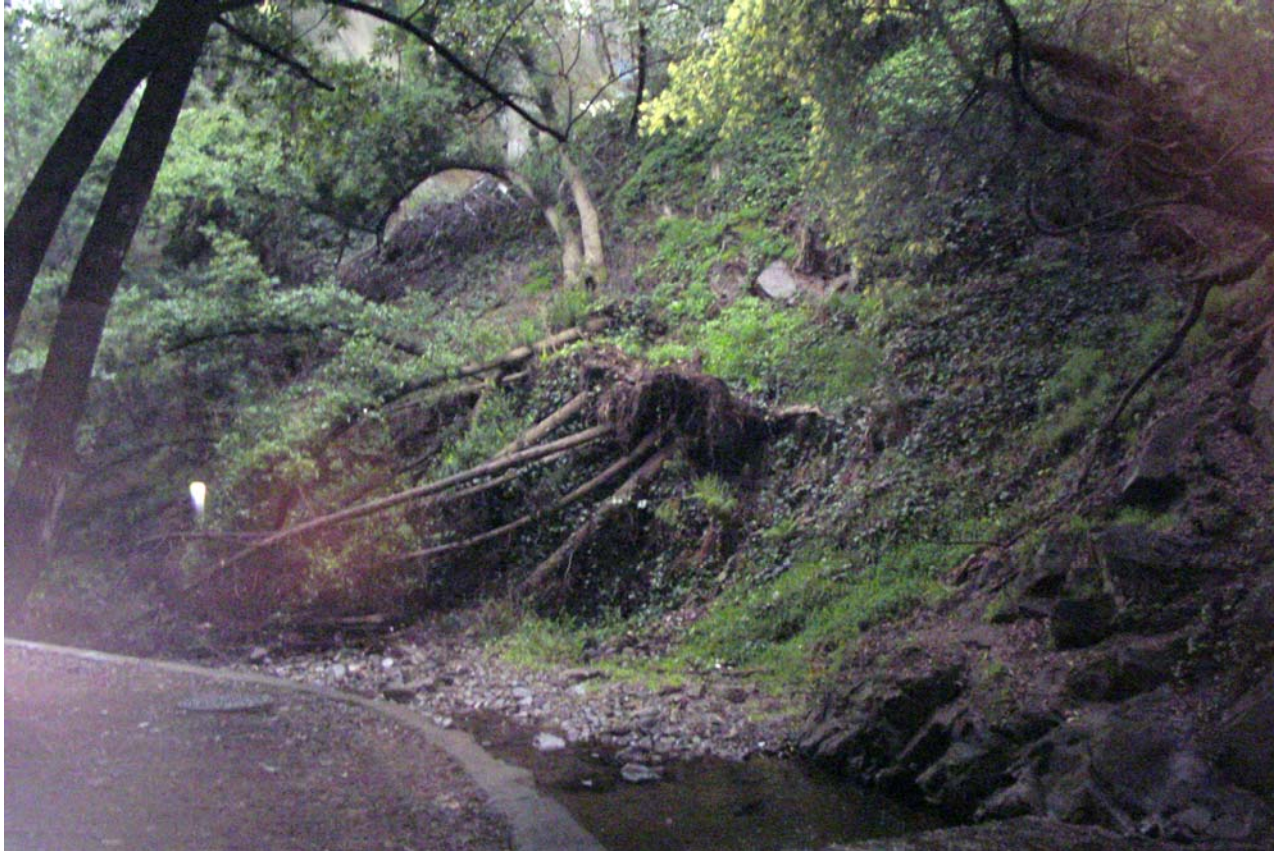
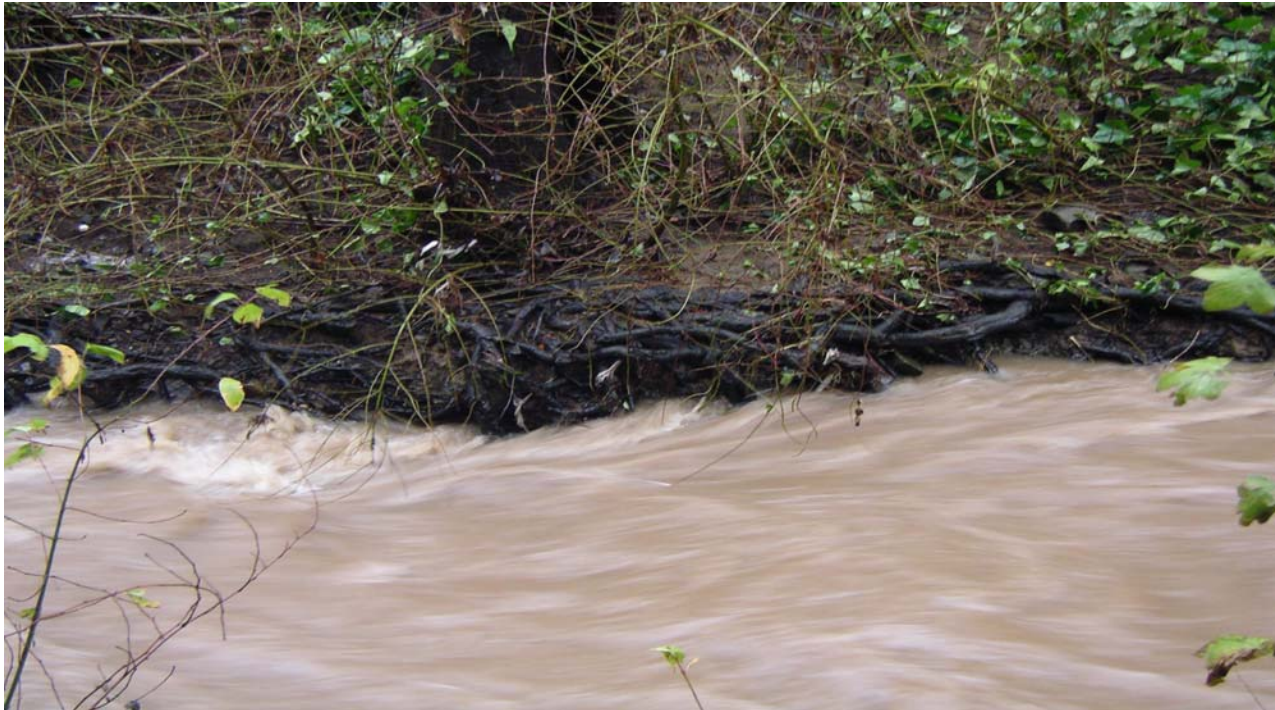
**Figure 66: Top: Erosion of bay trees along Sausal Creek (SC1) in Dimond Canyon.
Bottom: Roots of white alder (SC3) protect banks during floods.**

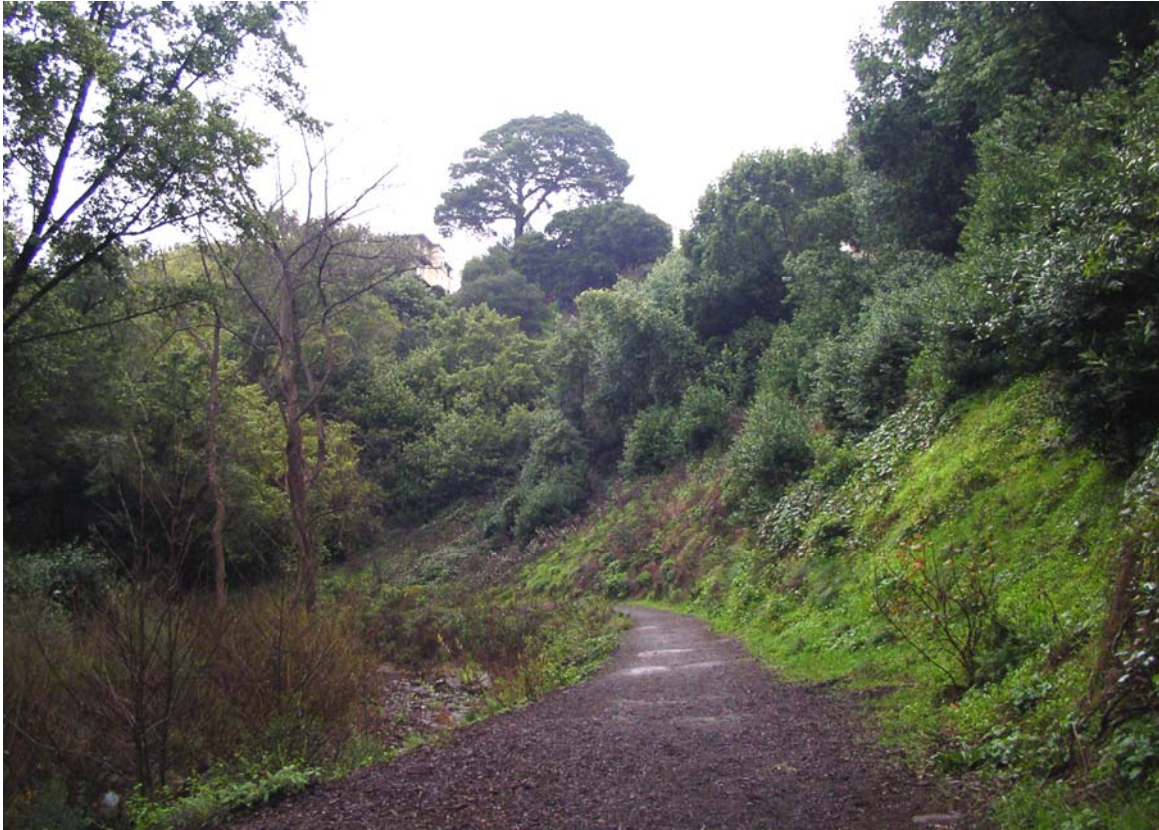
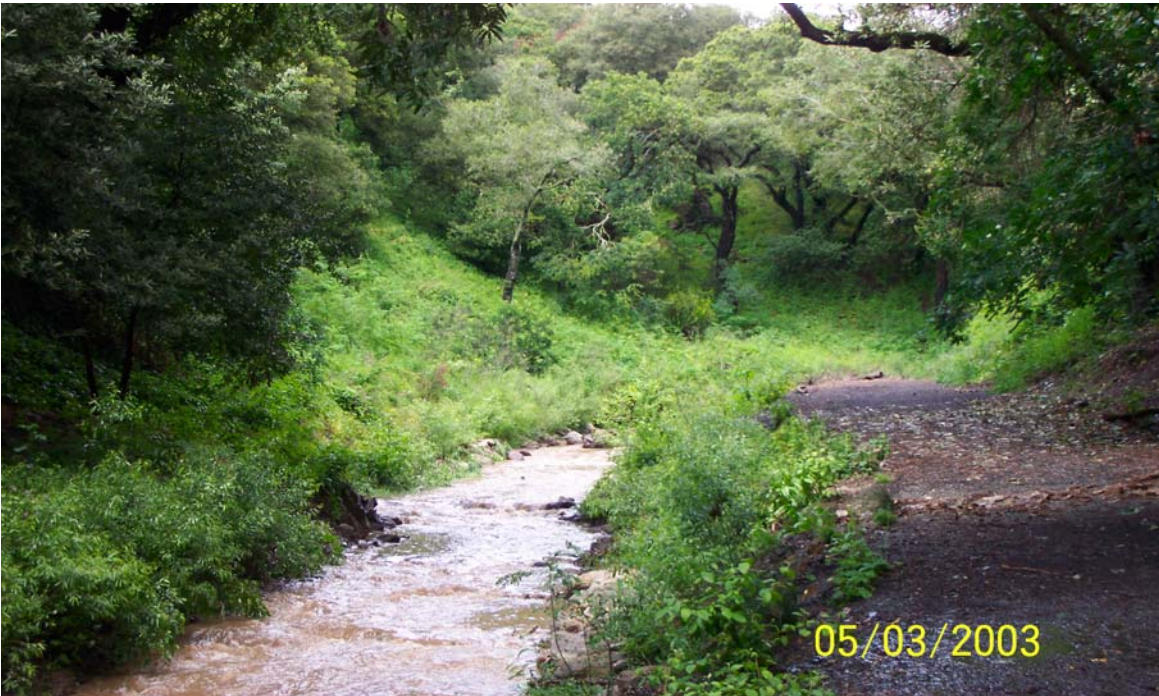
Figure 67: Top: California bay laurel trees were trimmed to open up the creek corridor to more light and allow for willow growth as part of the restoration project in SC2. Bottom: The project in 2003 shows the narrow riparian corridor and wide trail.
