AQUATIC AND RIPARIAN HABITATS

Stream Reach Description

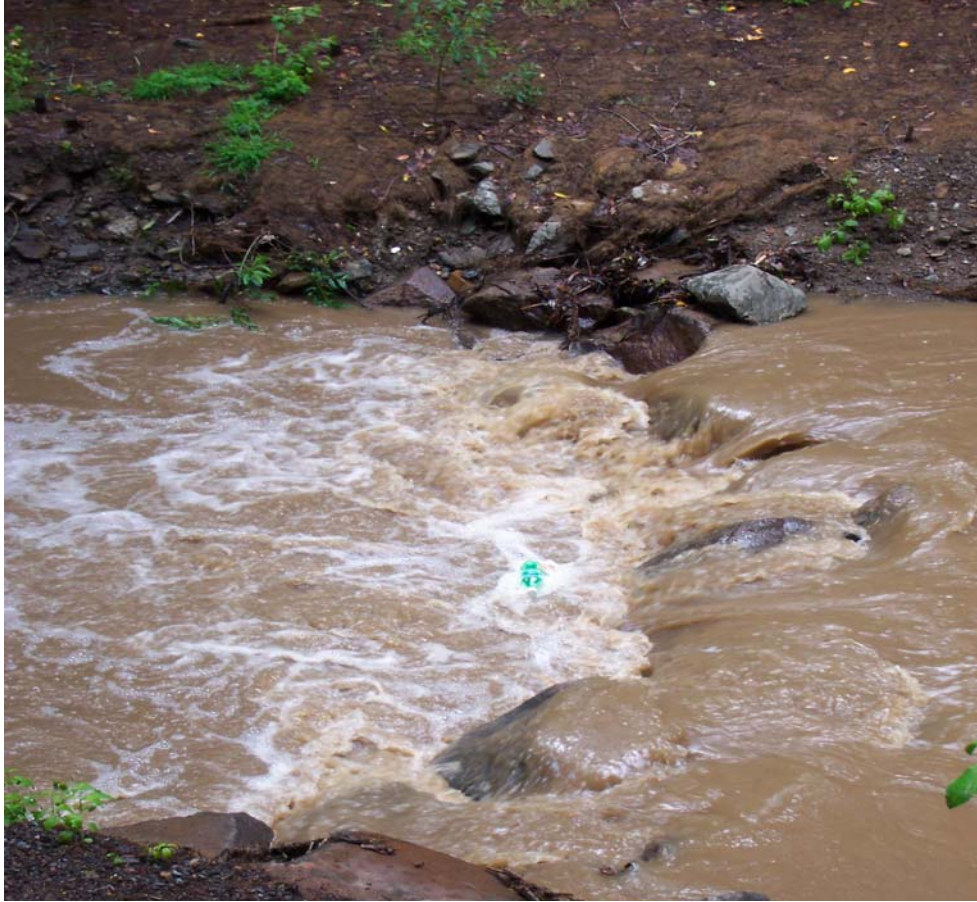
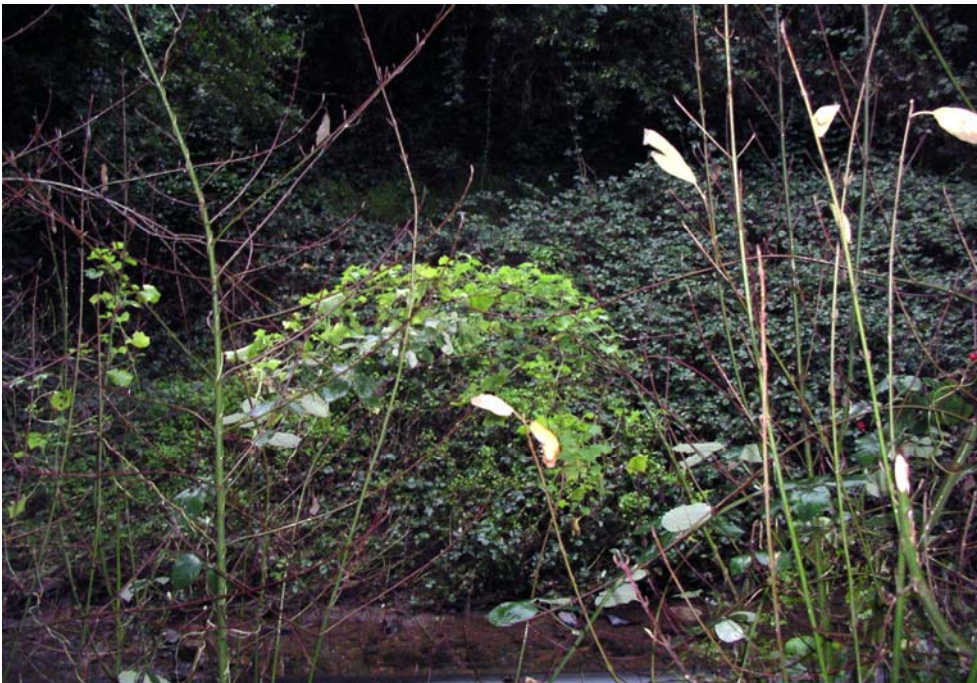
Figure 68: Top: Vortex weir in a small flood in 2003. The weirs were installed as part of the restoration project. Bottom: Invasive non-native plants invade the new willows in the restoration project (SC2).

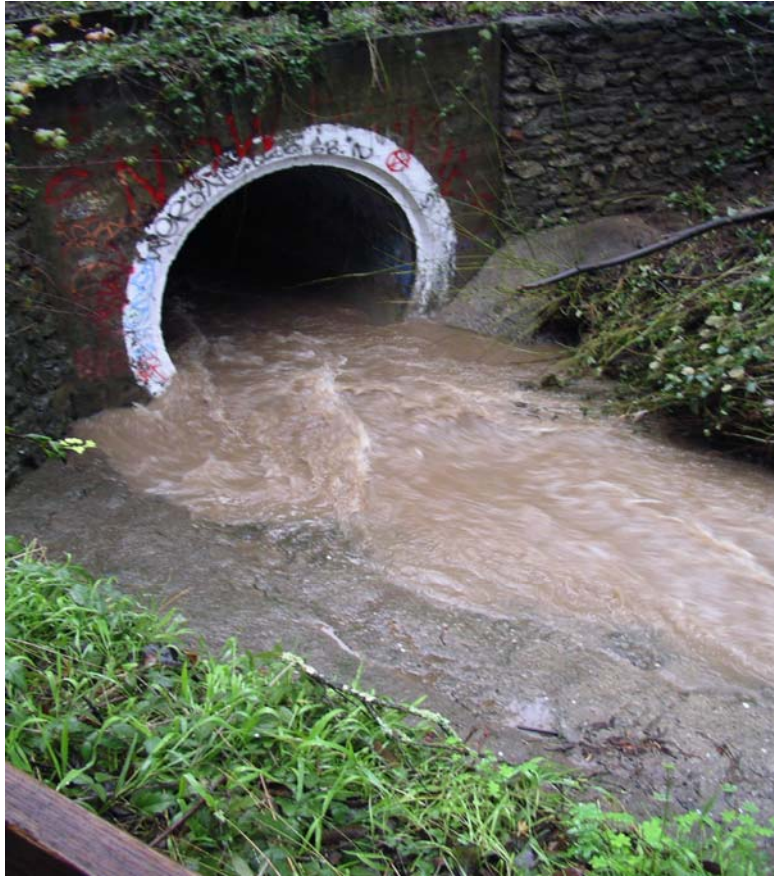
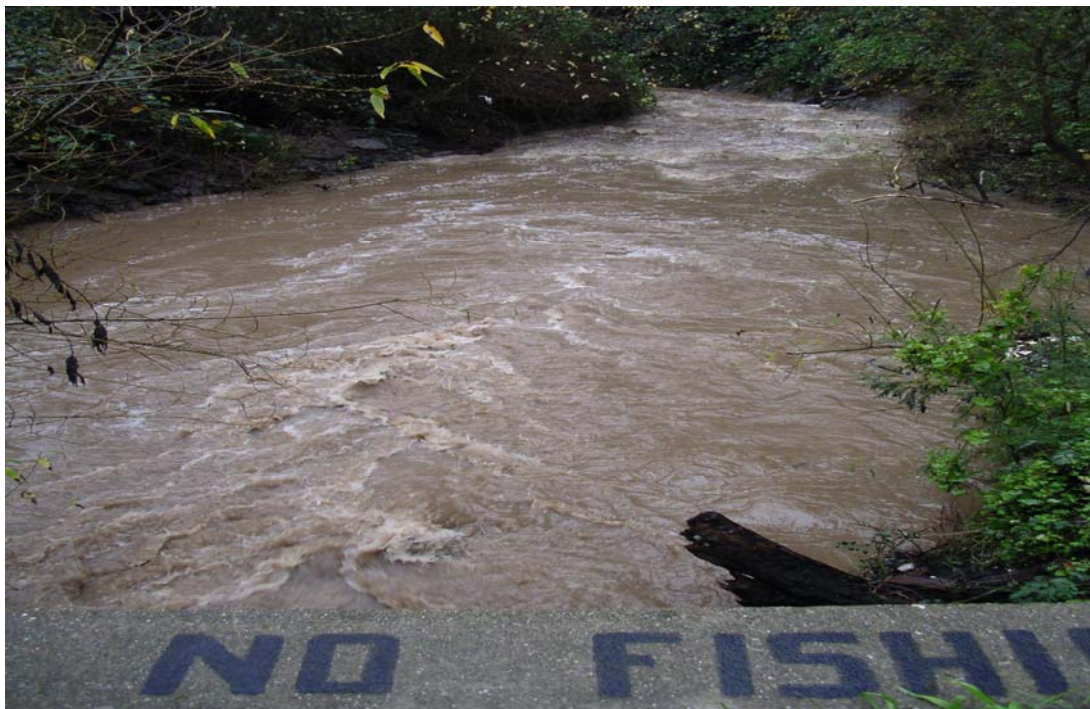
**Figure 69: Top: Upstream end of El Centro culvert in SC3.
Bottom: Downstream pool at outlet of El Centro culvert.**

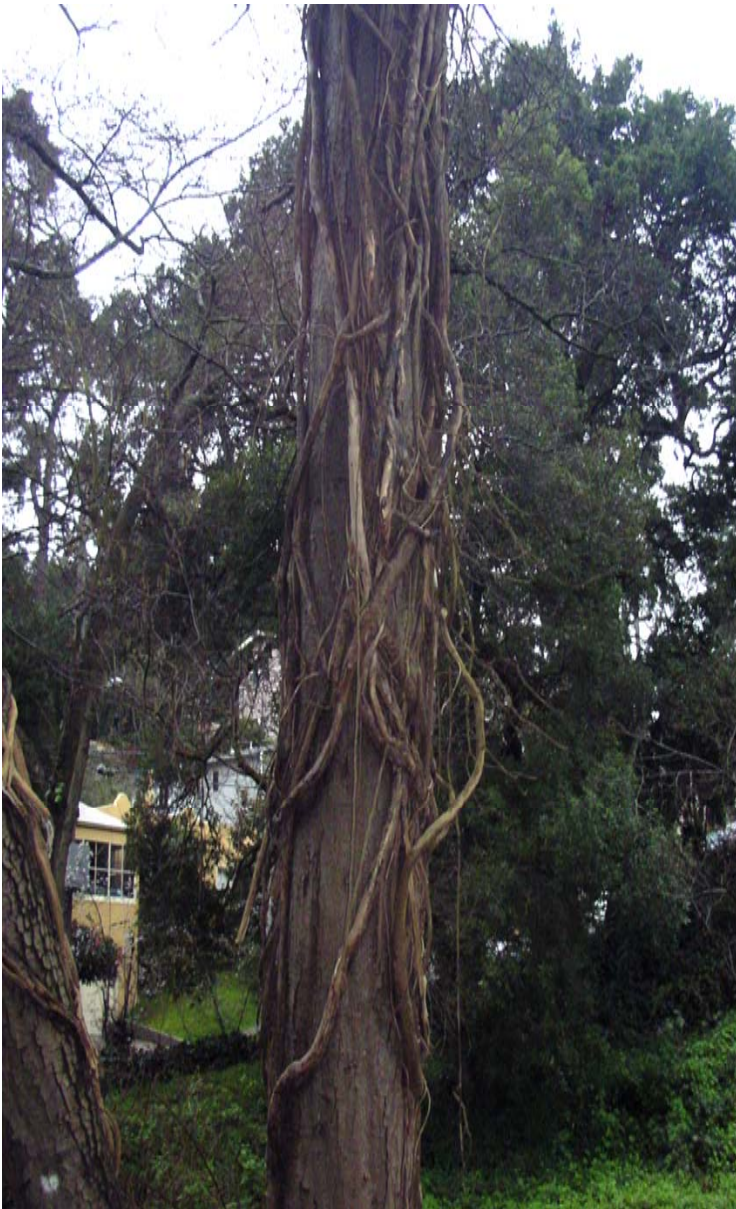
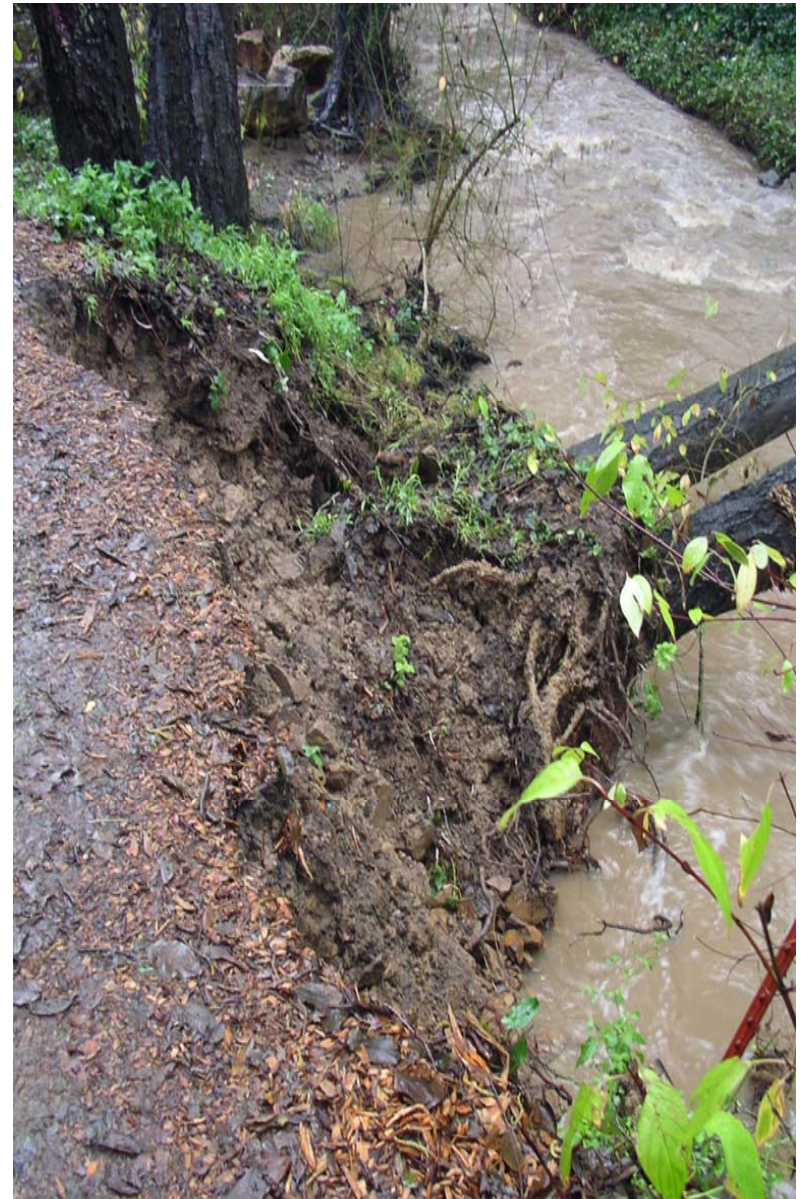
Figure 70: Left: White alder along Sausal Creek (SC3) with dead vines of Algerian ivy, a parasitic species. Right: Erosion of alders from the creek bank in the Jan 1, 2006 flood.

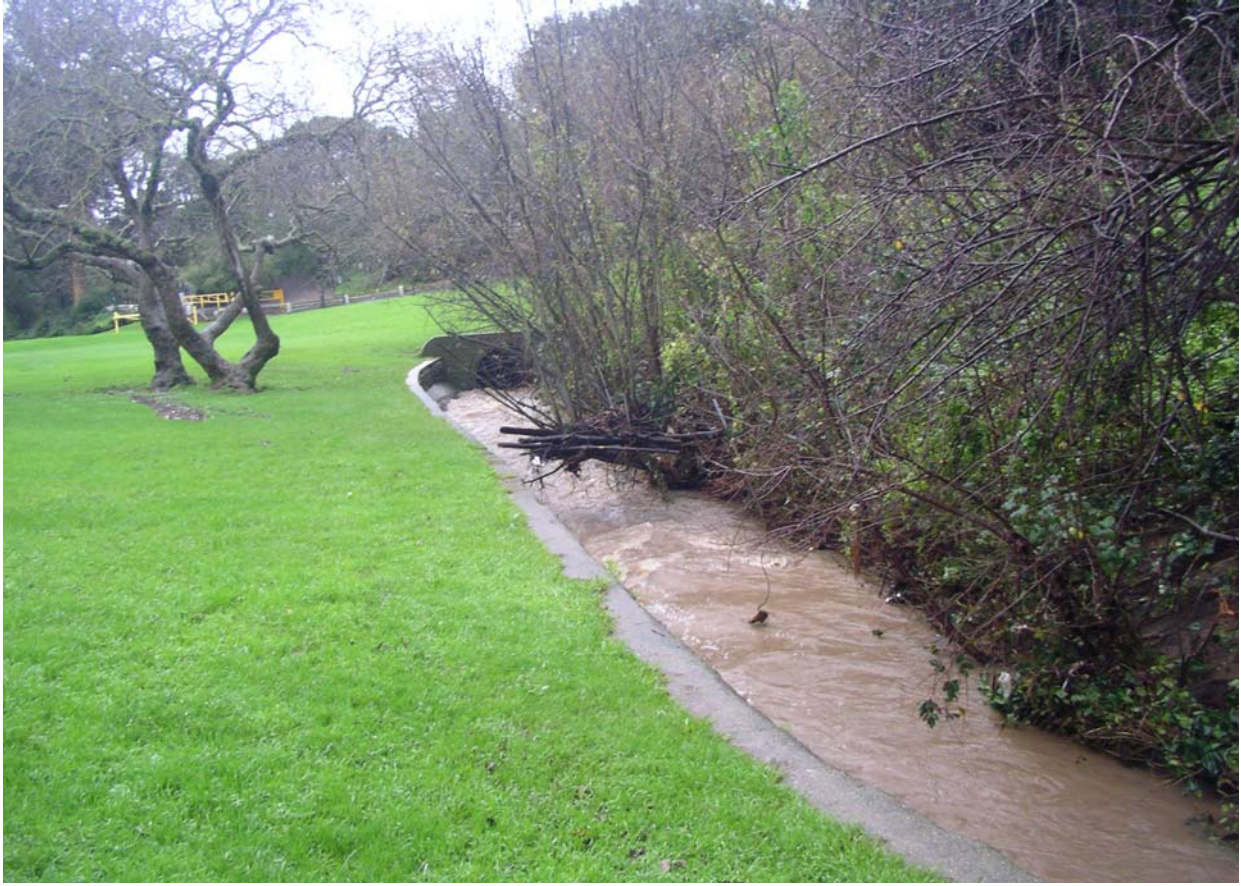
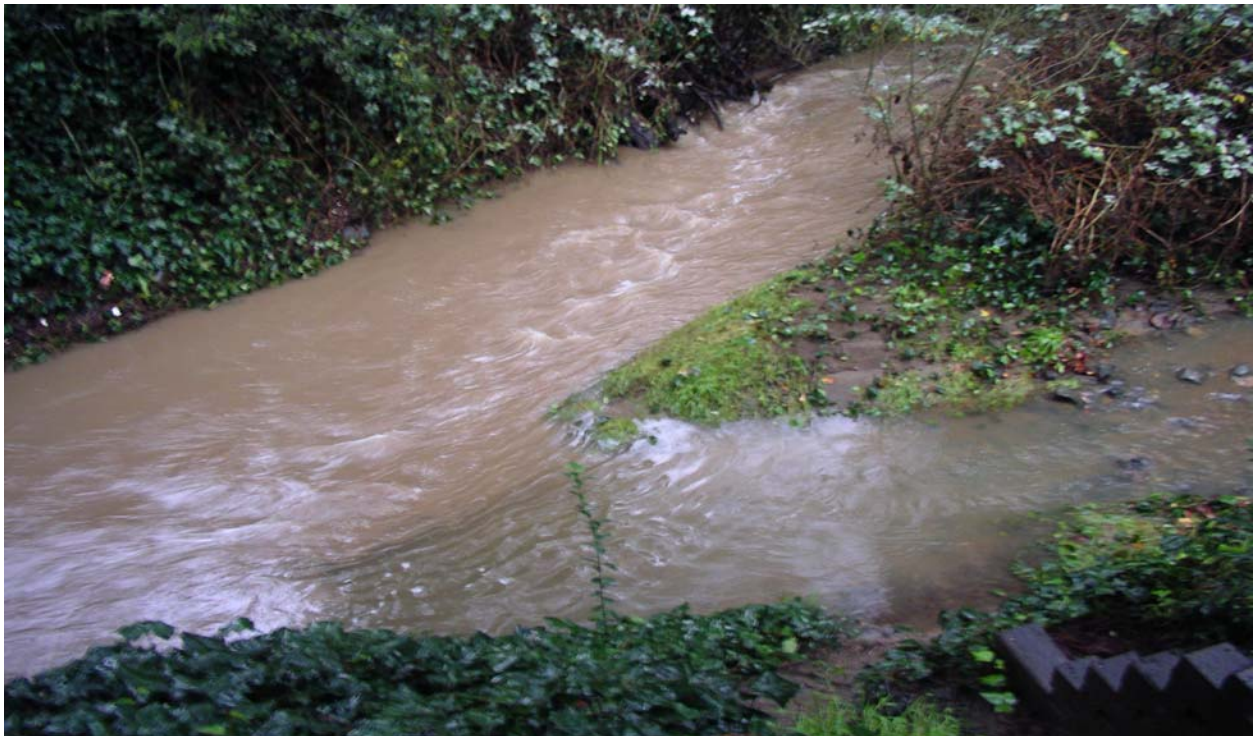
Figure 71: Top: Sausal Creek in Dimond Park (SC3). Bottom: Whittle Road tributary enters from its culvert into Sausal Creek.

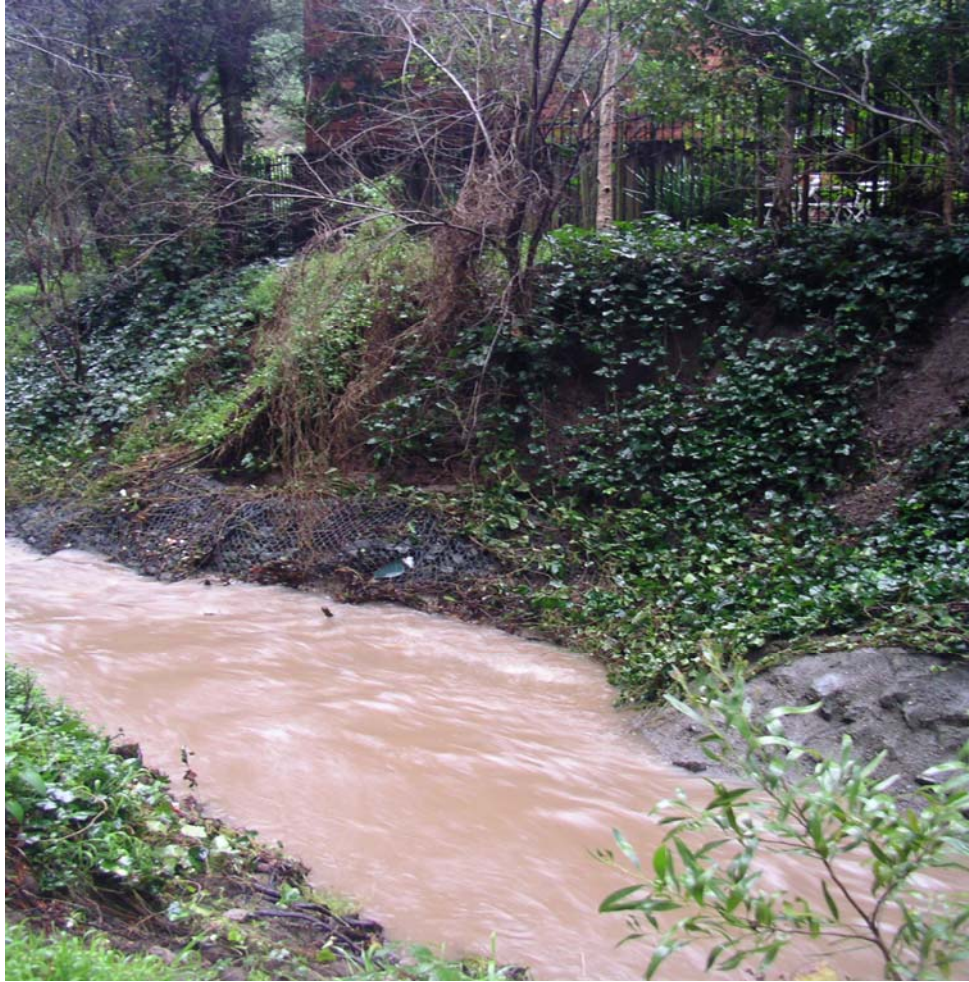
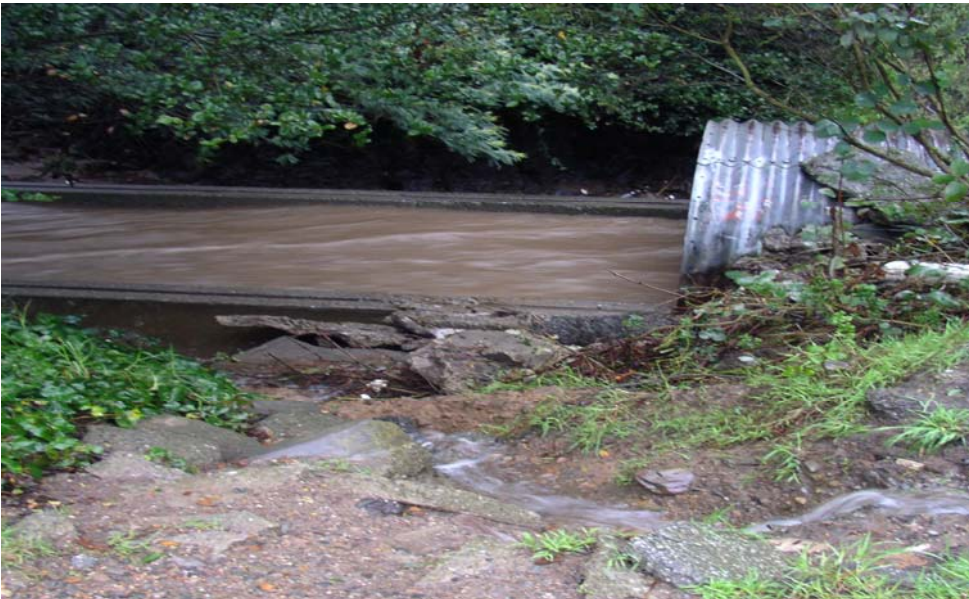
Figure 72: Top: Sausal Creek in downstream area of Dimond Park where private residences border the creek (SC3). Failed gabions (rock-filled baskets) remain from prior bank stabilization project. Bottom: Large culvert carries Sausal Creek under meadow.

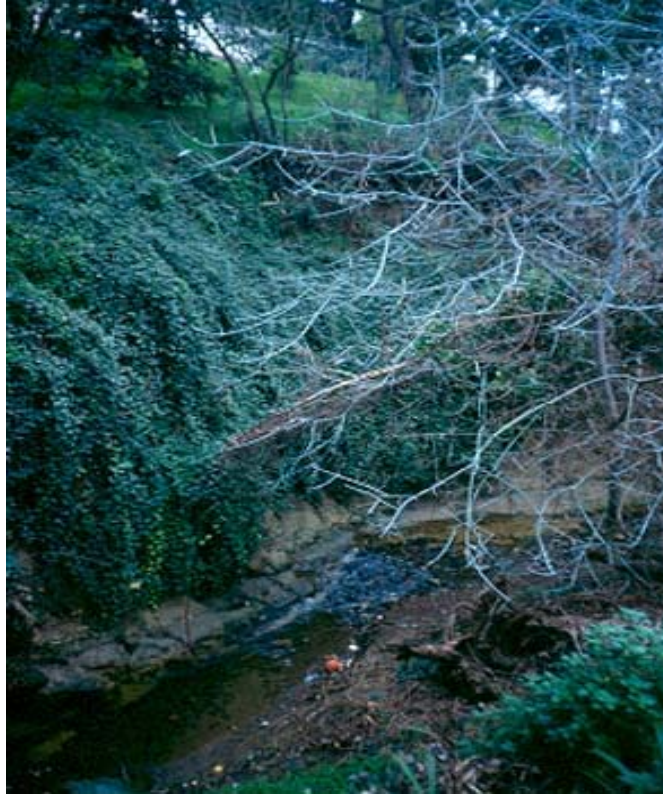
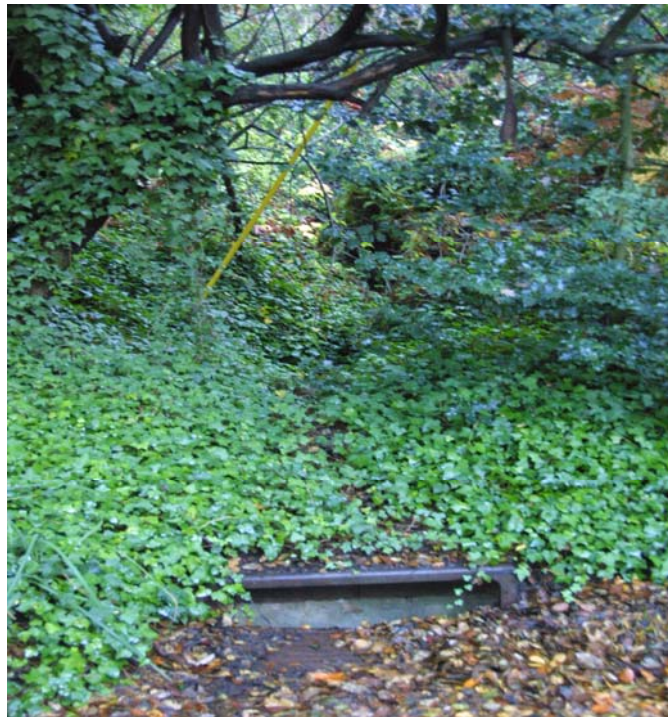
Figure 73: Top: Sausal Creek downstream of Hwy 580. The channel is entrenched and has little gravel in its bed or native trees on its banks. Bottom: Algerian ivy covers trees along many of the small ephemeral streams in the watershed and is a source of re-infestation to downstream restoration areas.

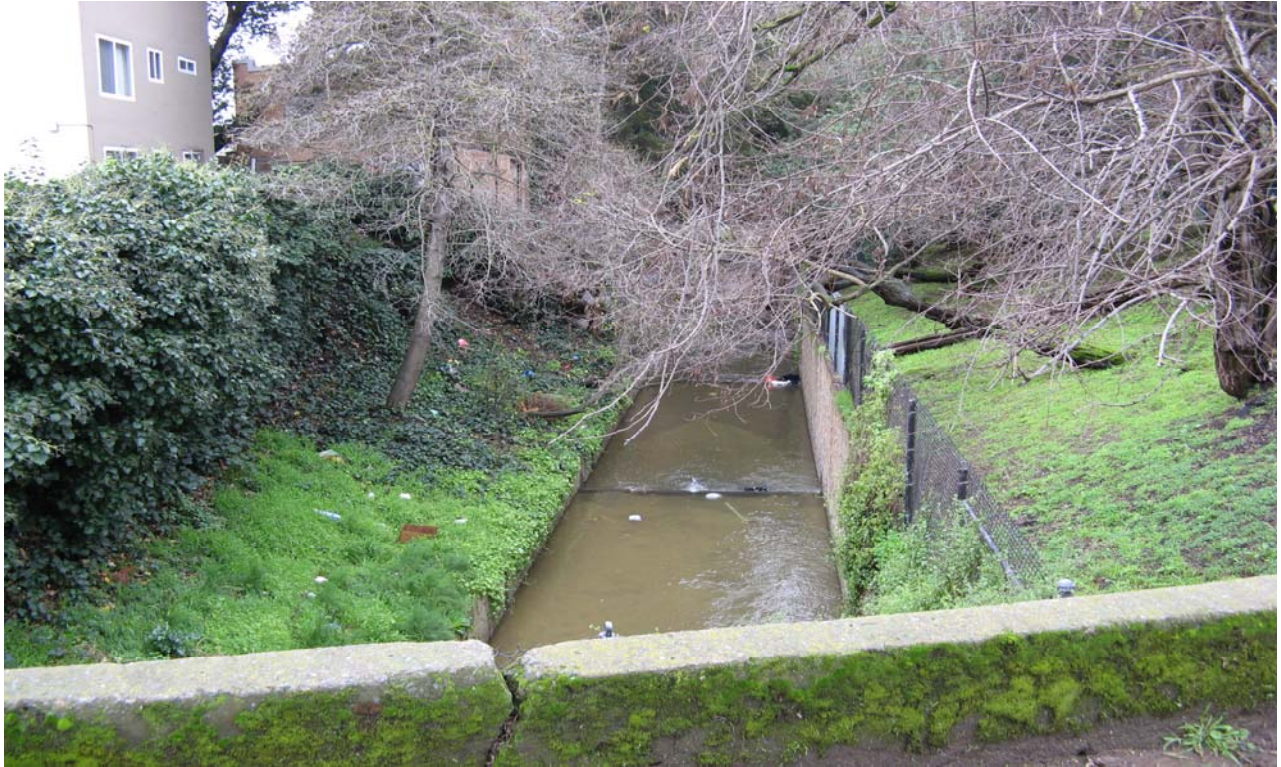
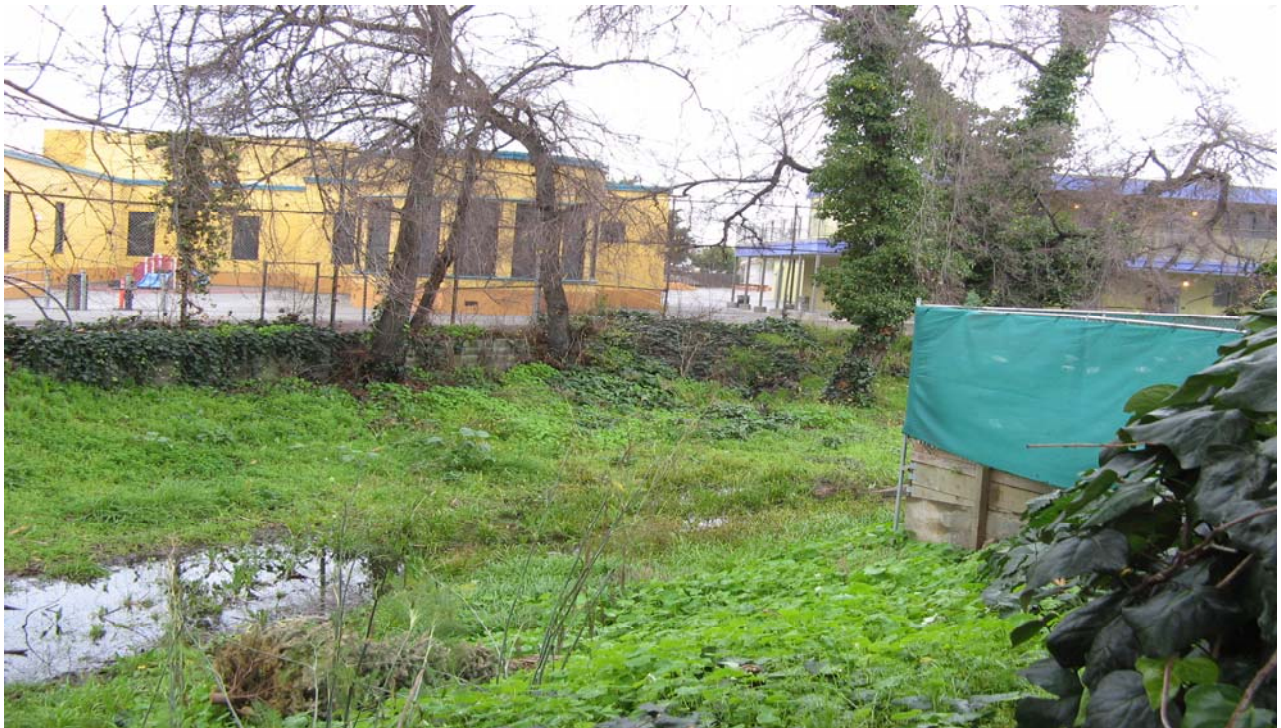
Figure 76: Top: Sausal Creek at Foothill Blvd in SC5. Bottom: Grassy area on top of culverted section of Sausal Creek.
